3 WTC 3

3.1 Design and Construction Features

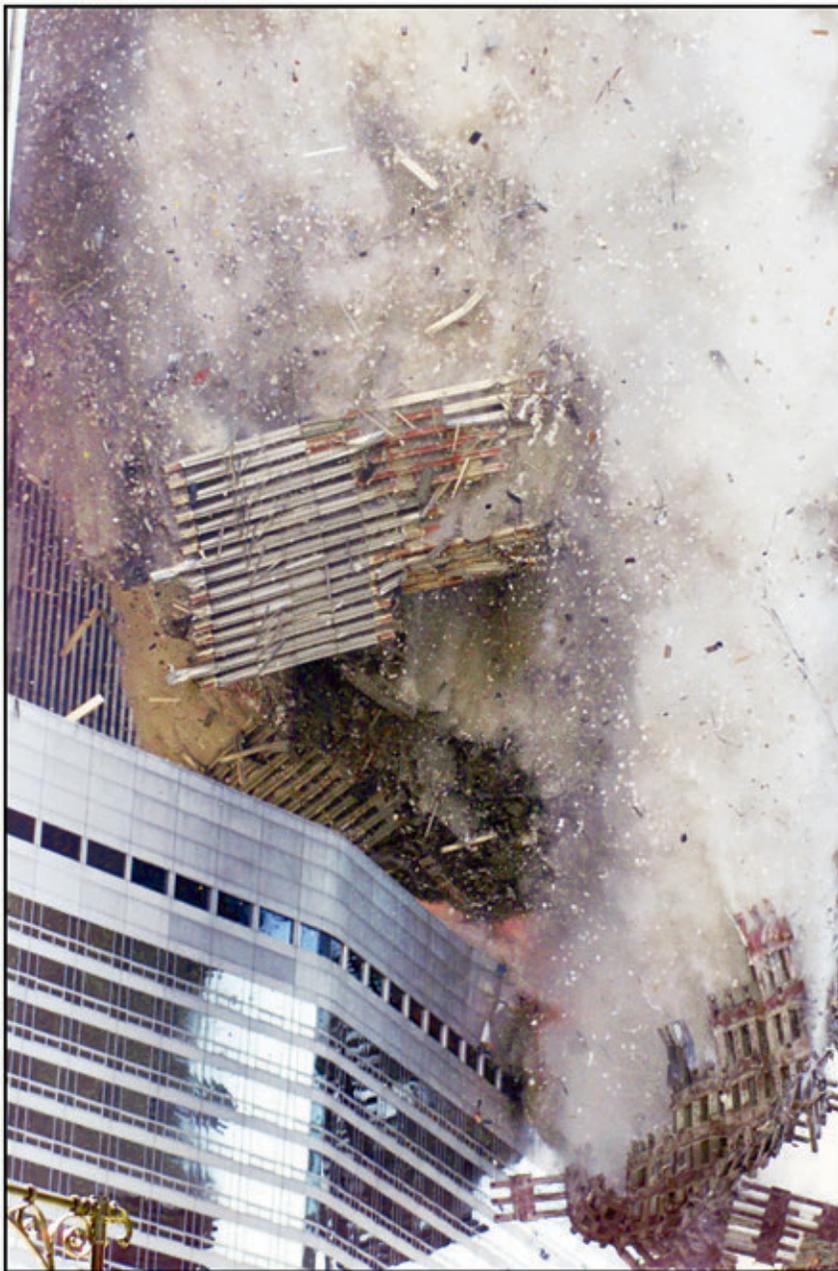
The response of WTC 3 to the September 11 events is complex and noteworthy. WTC 3 was subjected to two loading events. The first event involved the collapse of WTC 2, which stood immediately east of WTC 3. Due to its proximity to WTC 2, substantial amounts of debris fell directly on the roof of WTC 3. Figure 3-6 shows large portions of the prefabricated assemblies from WTC 2 falling on top of WTC 3.

*Figure 3-6
Exterior columns from WTC 2 collapse
falling on the southern part of WTC 3.*

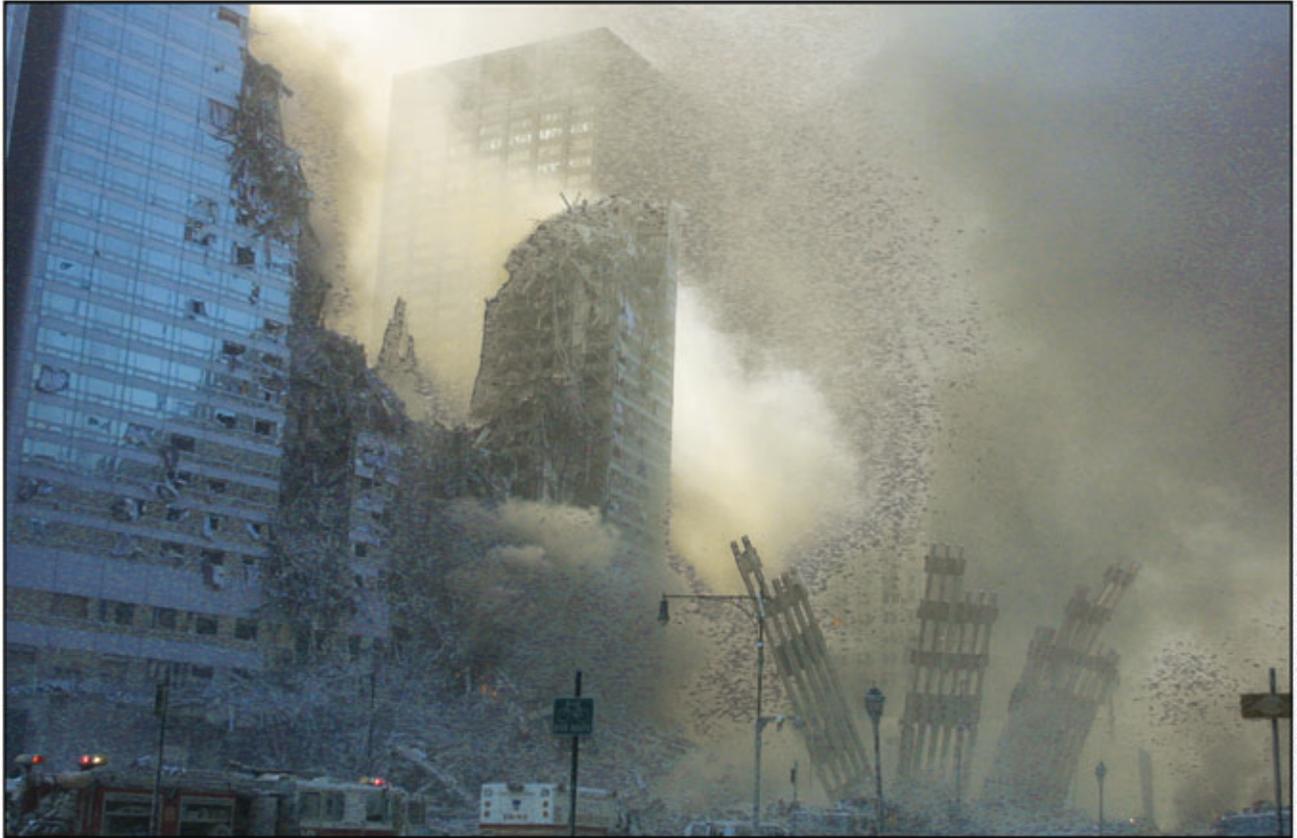
Debris from WTC 2 struck the building with sufficient force to crush approximately 16 stories in the center of the building, as shown in Figure 3-7. In spite of this extensive damage, the collapse did not continue down to the foundations or extend horizontally to the edges of the structure. In fact, the two

Figure 3-7 Partial collapse of WTC 3 after collapse of WTC 2.

northernmost bays (approximately 60 feet) remained intact all the way to the roof. A similar, but lesser condition existed in the southern bays. Even in the center of the building, the collapse stopped at approximately the 7th floor. This arrested collapse implies that the structure was sufficiently strong and robust to absorb the energy of the falling debris and collapsed floors, but at the same time the connections between the destroyed and remaining framing were able to break apart without pulling down the rest of the structure. This complex behavior resulted in the survival of large portions of the building following the collapse of WTC 2.

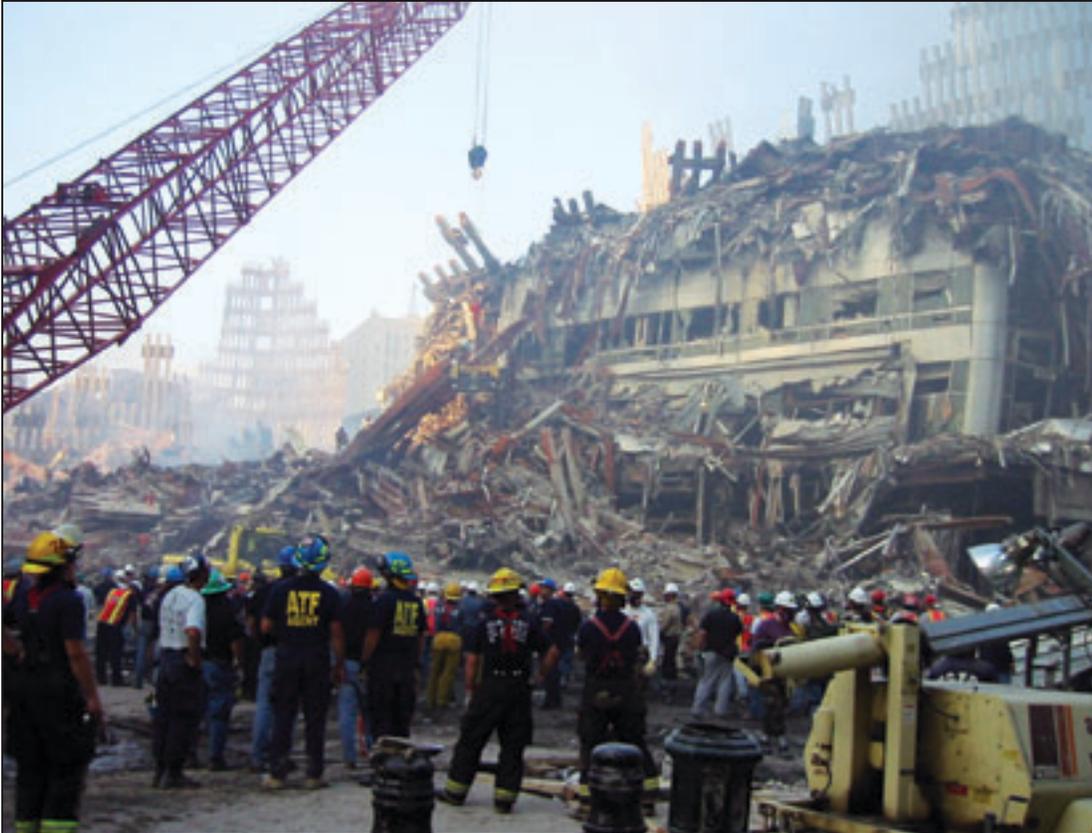
The second loading event was the collapse of WTC 1. Debris from WTC 1 fell along the entire length of the hotel. Lower floors at the southwest end of WTC 3 survived although they suffered extensive damage. The remaining portions of the building after both collapses of WTC 1 and WTC 2 are shown in Figure 3-8.

Figure 3-8 Remains of WTC 3 after collapse of WTC 1 and WTC 2.

WTC 3 was subjected to extraordinary loading from the impact and weight of debris from the two adjacent 110-story towers. It is noteworthy that the building resisted both horizontal and vertical progressive collapse when subjected to debris from WTC 2. The overloaded portions were able to break away from the rest of the structure without pulling it down, and the remaining structural system was able to remain stable and support the debris load. The structure was even capable of protecting occupants on lower floors after the collapse of WTC 1.

WTC 3 should be studied further to understand how it resisted progressive collapse.
